Eyeball Home Inspection Services

Property Inspection Report

.1234 Brookhaven Ct, Fontana, CA 92336
Inspection prepared for: Don Quijote & .Micaela Quijote
Date of Inspection: 8/5/2013 Time: 10:00 AM
Age of Home: 2005 (8 yrs) Approx Size: 3683 ASF (Approx)
Weather: 84 Deg F (Sunny)
Report #050813A; Date of last significant rain: March 8, 2013 (Approx)

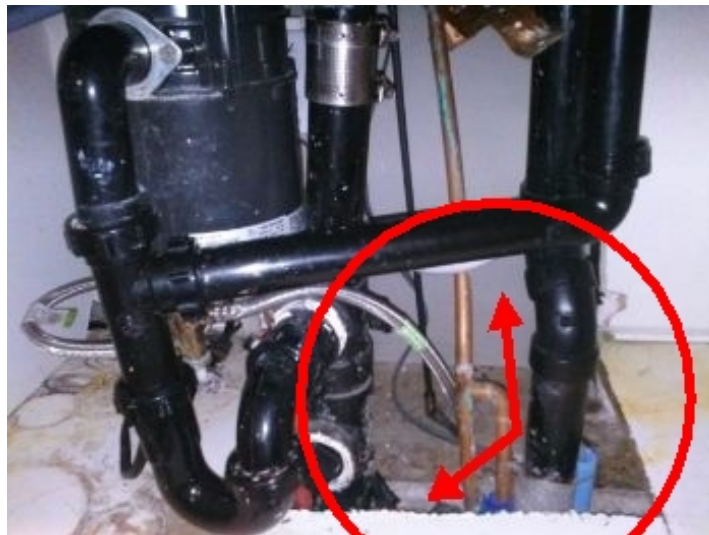
Voids in Sink lower Cabinet floor board and rear sidewall

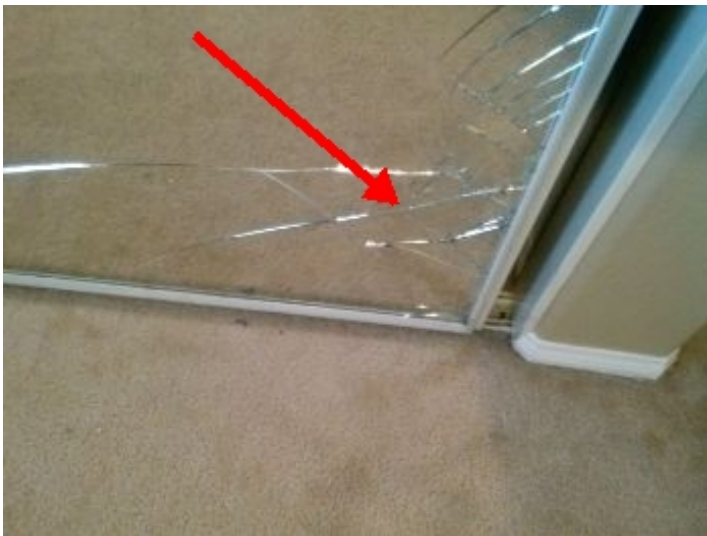
• **CLOSET DOOR MIRROR CRACKED: Bedroom #3: Closet Mirror Cracked at lower edge. Recommend repair by a qualified contractor (Safety)**

Bedroom #3: Closet Mirror Cracked at lower edge

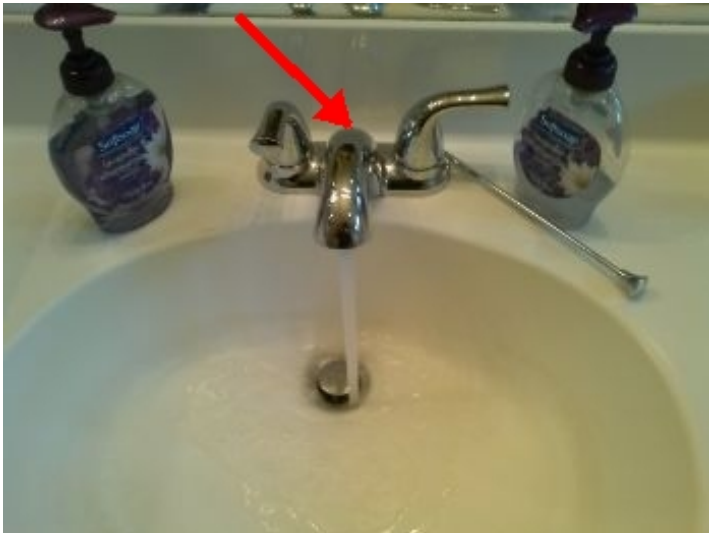
- **DRAIN STOPS:** Lower Floor Hallway bathroom sink drain stop disconnected
- **TOILETS:** Fill Valve Recycling in hallway bathrooms- Fill valve may be in the early stages of failure. Recommend review for repair by a state licensed plumbing contractor when practical

Lower Floor Hallway bathroom sink drain stop disconnected

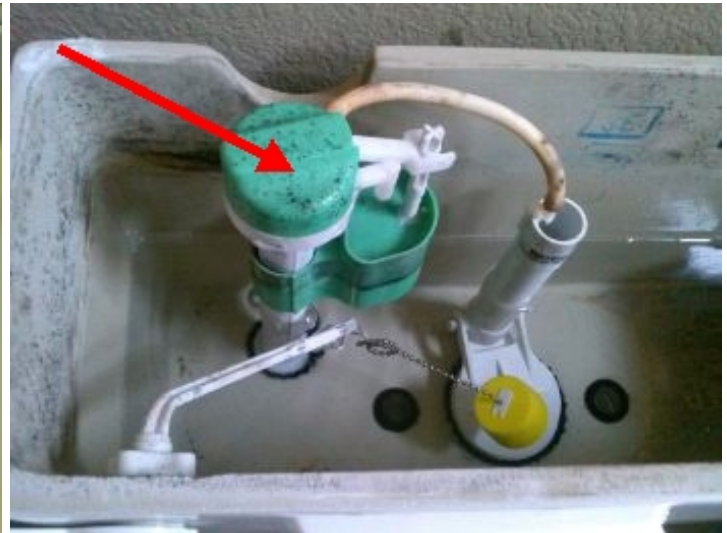
Hallway bathrooms: Fill valve recycles

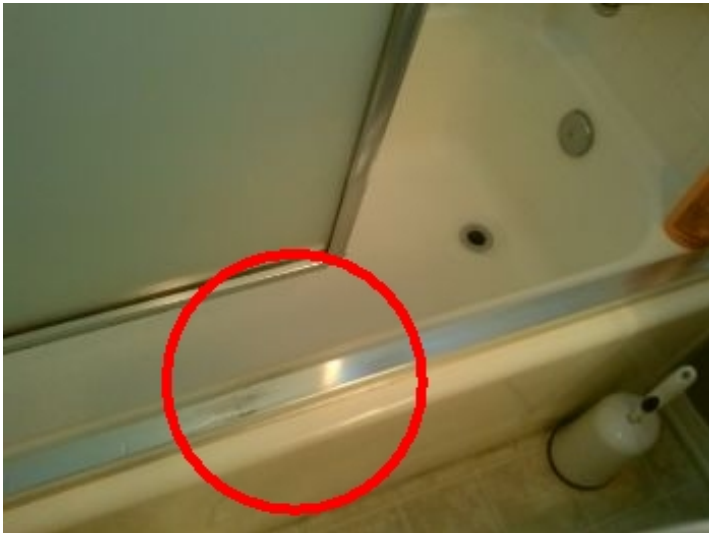
- **CABINETS :** All Functional
- **DOORS :** Operated- All Opens/closes/locks
- **SHOWER DOORS:** Upper Floor Hallway bathroom- Shower door Track guides not installed. Recommend repair (safety)

Upper Floor Hallway bathroom: Sliding shower door track guides not installed

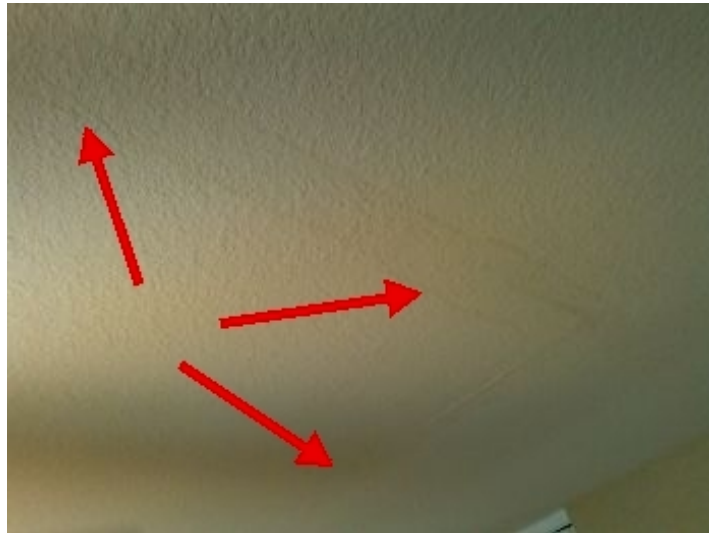
- CEILINGS: Bedroom #4: Dry ceiling stains observed. Stains were Tested for high levels of moisture and tested dry day of inspection. Contact qualified contractor for service and repair options if problem persists
- CEILINGS: Functional
- WALLS: Functional
- FLOORS: Functional
- Floor carpet stained, soiled dirty - Recommend professional cleaning.

Bedroom #4: Dry ceiling stains observed

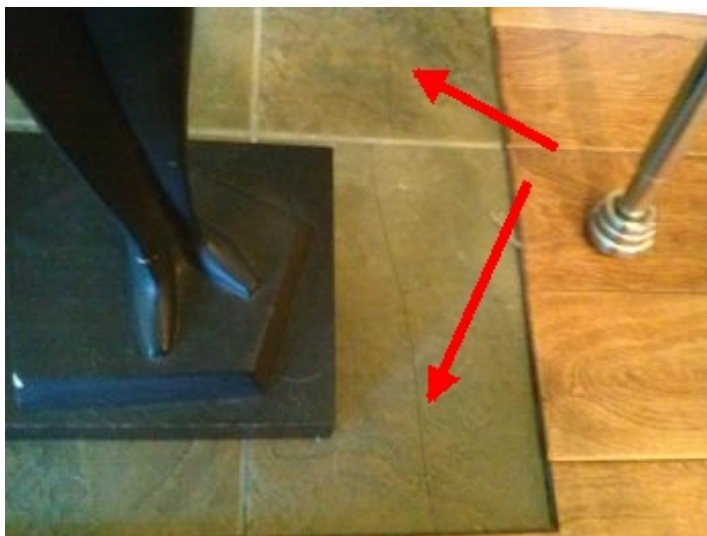
- **HEARTH: TYPE- TILE;** Fire safety requirements of 16" to 18" met. NOTE: Minor Tile Crack at right side of hearth extension observed. No issues found
- **FLUE INTERIOR:** Dirty- Creosote and Soot visible-Both Creosote and Soot can fuel a chimney fire! Recommend a level 2 Fireplace Safety Inspection-Interior surfaces of metal updraft flue not accessible
- **FIREPLACE TYPE:** PREFABRICATED
- **TYPE:** GAS STARTER
- **CONDITION:** Functional
- **BIFOLD GLASS PANELS INSTALLED:**Functional
- **FLUE DAMPER GATE:** Functional/Opens & Closes
- **WALL SWITCH:** Wall switch operated and was tested and operated. Functional at time of inspection
- **FIREBOX SCREEN:** Functional- Opens/closes

Minor Tile Crack at right side of hearth extension

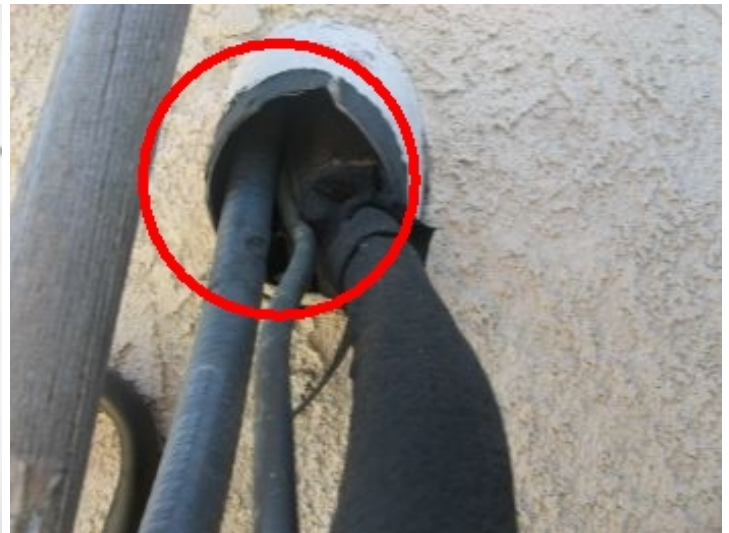
- Insulation wrap missing from plumbing and electrical wiring at sidewall entry point. Recommend insulation wrap to prevent water intrusion and damage. (Preventative maintenance)

AC condenser equipment feed through at sidewall not covered

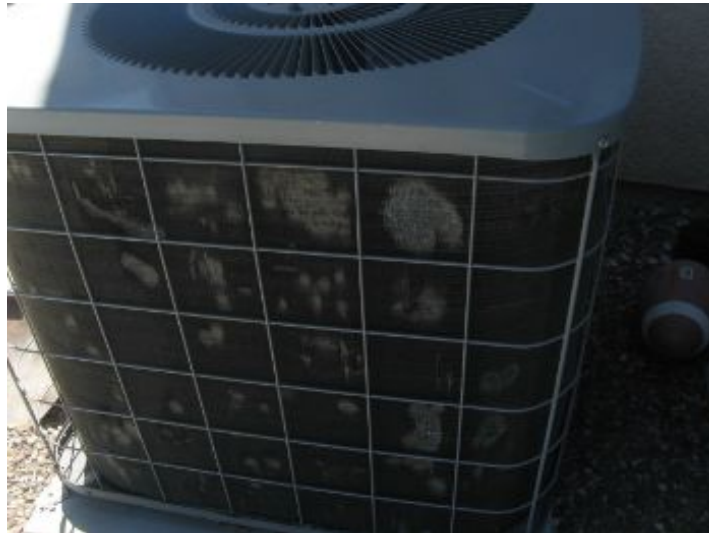
- COOLING FIN DAMAGE: AC condenser assembly located at exterior rear sidewall - Section of cooling coil fins meshed together and may affect cooling efficiency of system increasing energy costs. During operation cooling system normally operated and cooled.

Condenser cooling fins slight damage

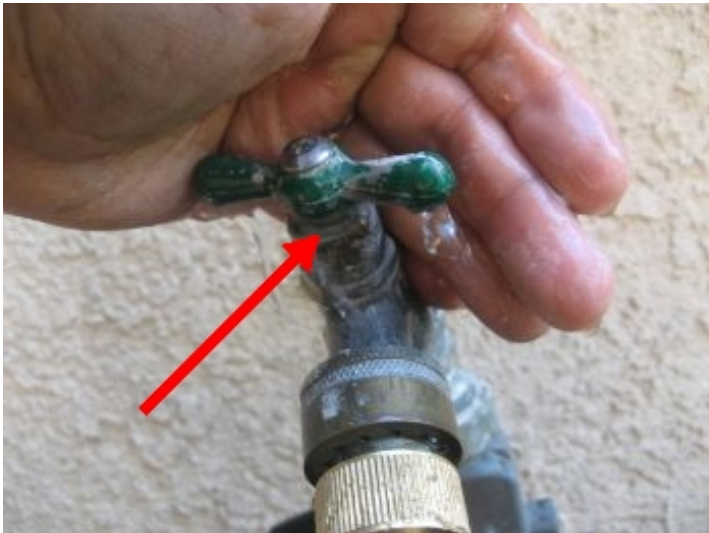
- Front exterior hose faucet valve leaks at handle valve stem. Recommend repair/replacement of valve.
- Natural gas meter and shut off valve: Location: Front exterior sidewall
- Gas plumbing line at sidewall entry point has void. Recommend sealing to prevent vermin and water intrusion.

Front sidewall spigot hose valve leaks

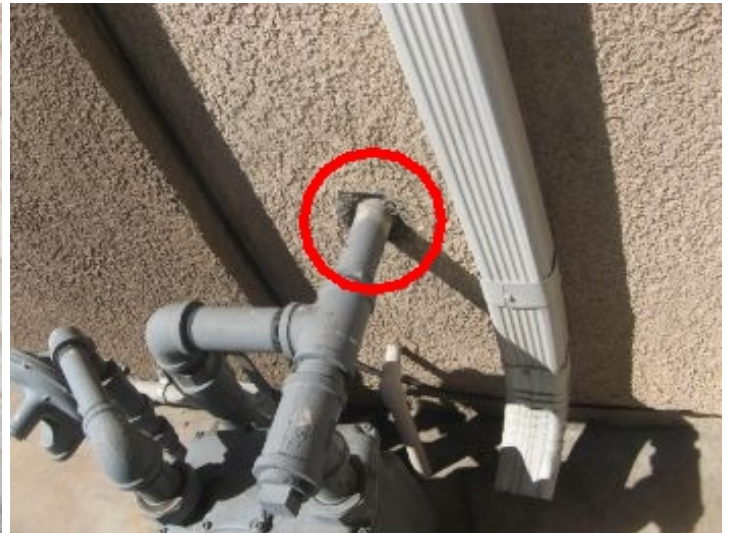
Gas plumbing voids at sidewall entry point

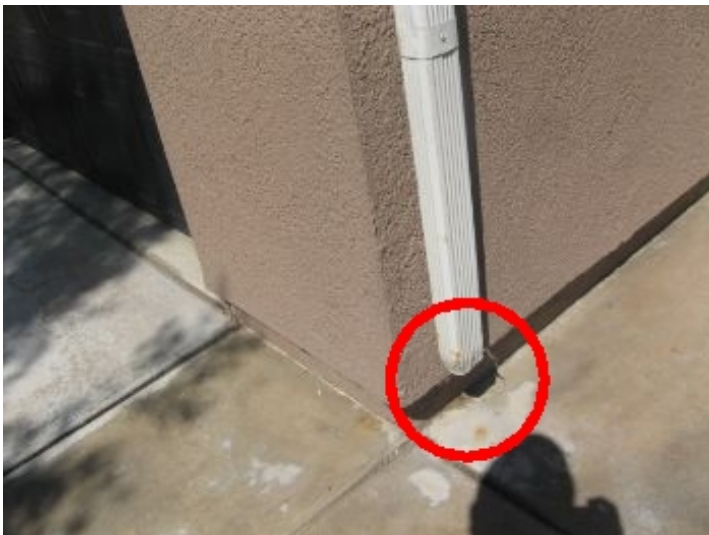
Rain gutter downspout end elbows not installed several locations

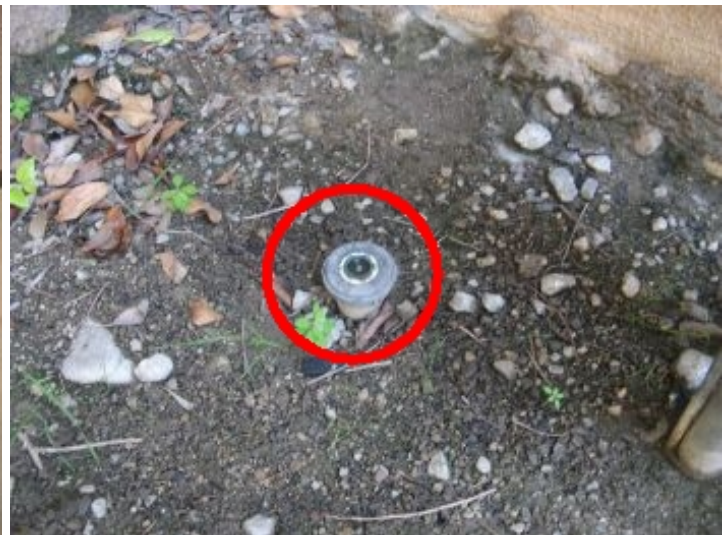
Sprinkler spray heads too close to sidewall systems

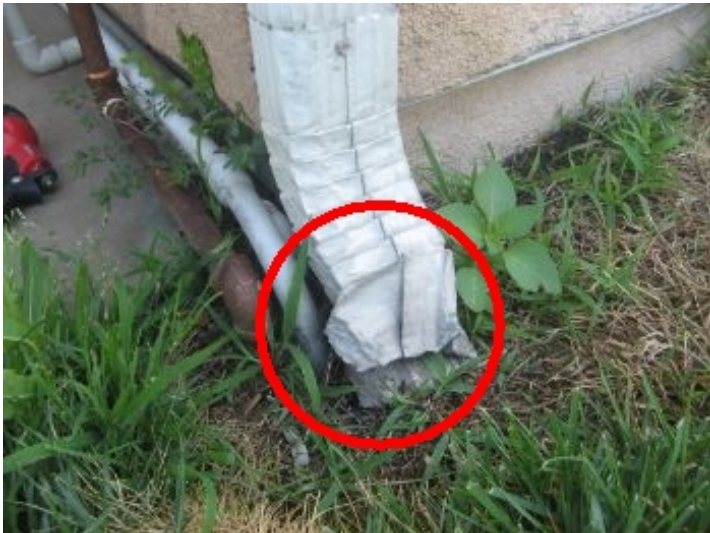
Gutter downspout end elbows crushed several locations

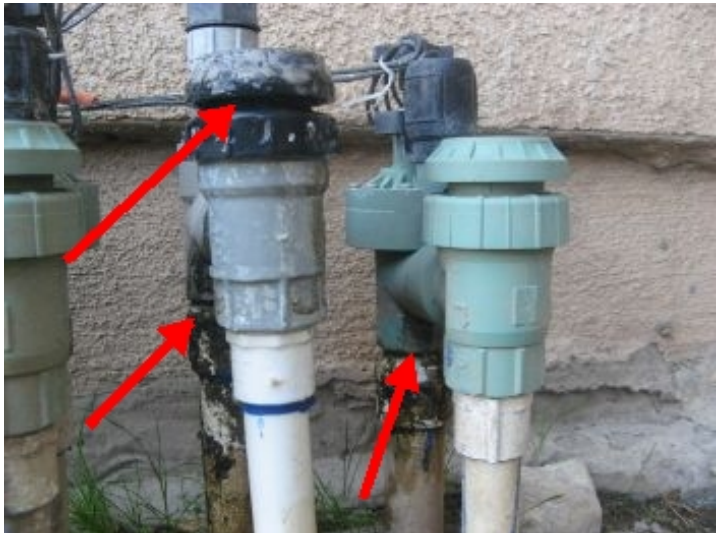
- **Sprinkler control valves located at rear sidewall leaking. Recommend repair**

Rear sidewall sprinkler control valves leak

Page 23 Item: 5	Gutters, Grading, & Sprinkler System	<ul style="list-style-type: none"> • Sprinkler control valves located at rear sidewall leaking. Recommend repair
-----------------	--------------------------------------	--

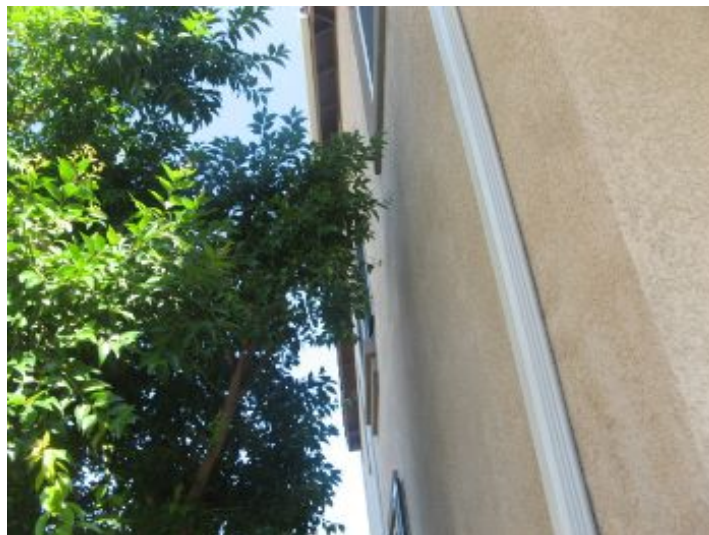
- Trees observed growing in close proximity of building foundation, siding and roof systems that may cause damage. Recommend maintaining clearance from siding to prevent damage, (Preventative maintenance)

Bushes growing contacting sidewall system

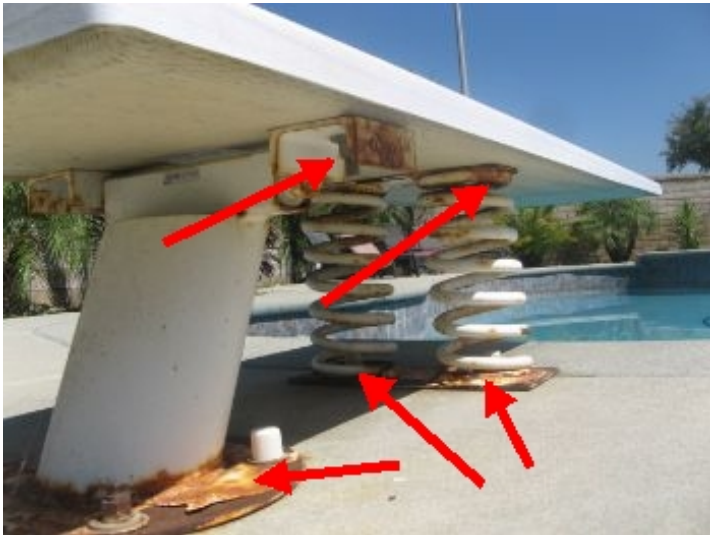
Diving board mount supports corroded

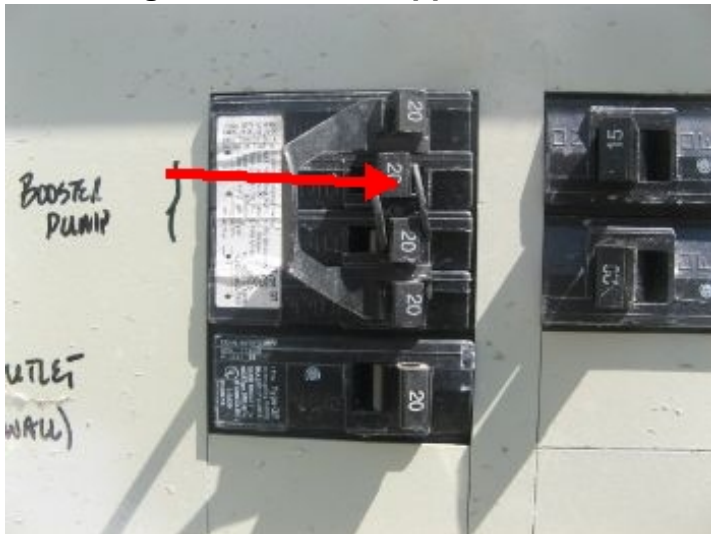
Sub panel 20A breaker tripped in "OFF"

<p>Page 27 Item: 1</p>	<p>Pool/Spa Condition</p>	<ul style="list-style-type: none"> • Electrical: Sub panel at pool equipment - 15A Breaker in found in tripped "OFF" position. Recommend state licensed electrician determine cause and repair. • Interior water lights inoperative - Spa Only - Recommend repair • Garage side door to side yard and pool area does not self close and latch. Recommend repair (Child safety) • Alarm audible devises not installed at rear and side area doors that lead to the pool water. Recommend the installation of approved alarms at all doors ;leading to the pool water (Child safety) • Protective fence barrier not installed between house and pool water areas. Recommend the installation of an approved fence barrier to prevent a small child from entering the pool water areas that may lead to drowning and death. (Child Safety) see Consumer Product Safety Commission (www.CPSC.gov/swimming pool safety for additional safety information)

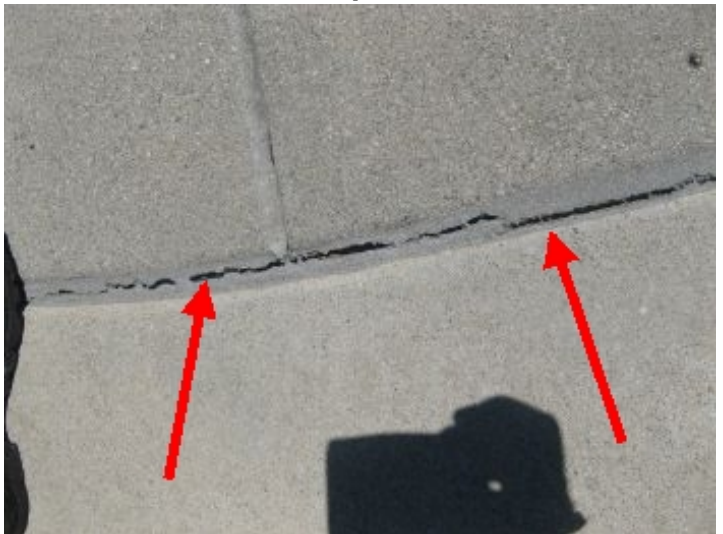
Deck seal voids
